REPORT NO. CASD/LVP 78-078  
CONTRACT NAS 3-20644

## ATLAS 5013 TANK CORROSION TEST

# ATLAS 5013 TANK CORROSION TEST

December 1978

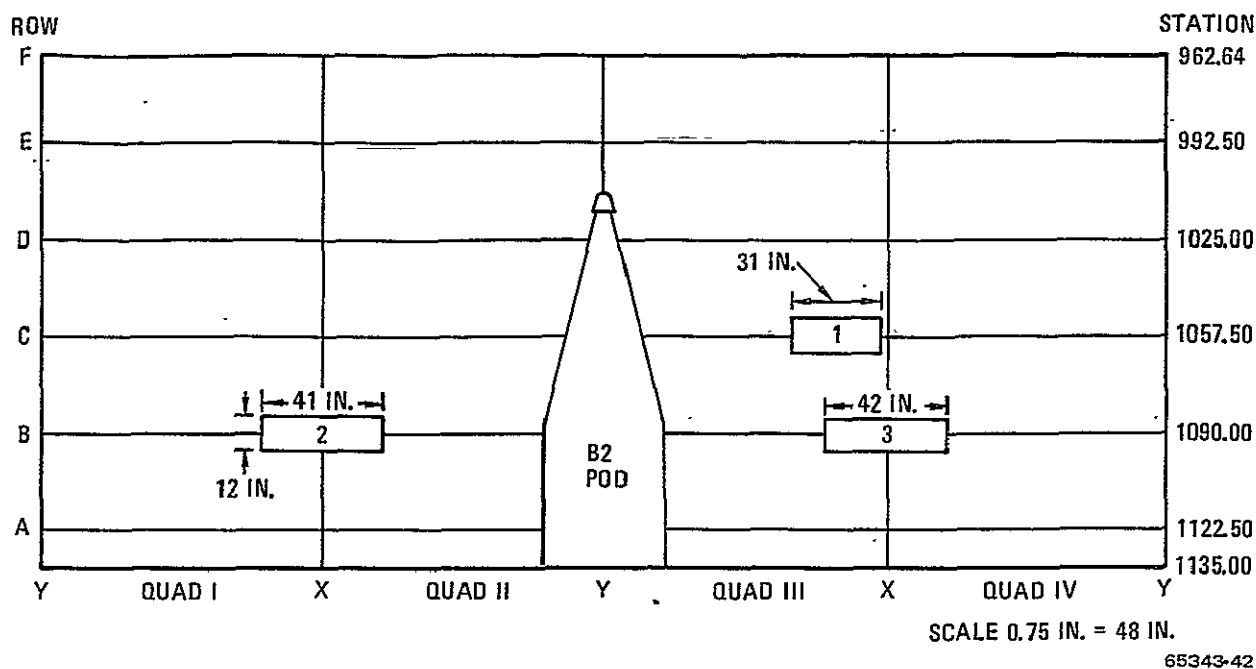
A metallographic test specimen panel (No. 1), 12 inches wide by 31 inches long, with the leaking defect approximately in the center, was cut from Row C. Two 12-inch wide metallographic panels (No. 2 and 3) were cut from Row B; each contained at least one leak defect. Panels 2 and 3 were 41 and 42 inches long respectively. The location of these panels in the overall fuel tank is shown in Figure 2-2.

Figure 2-2. Location of Metallographic Specimen Panels 1, 2, and 3 in the 5013 Fuel Tank

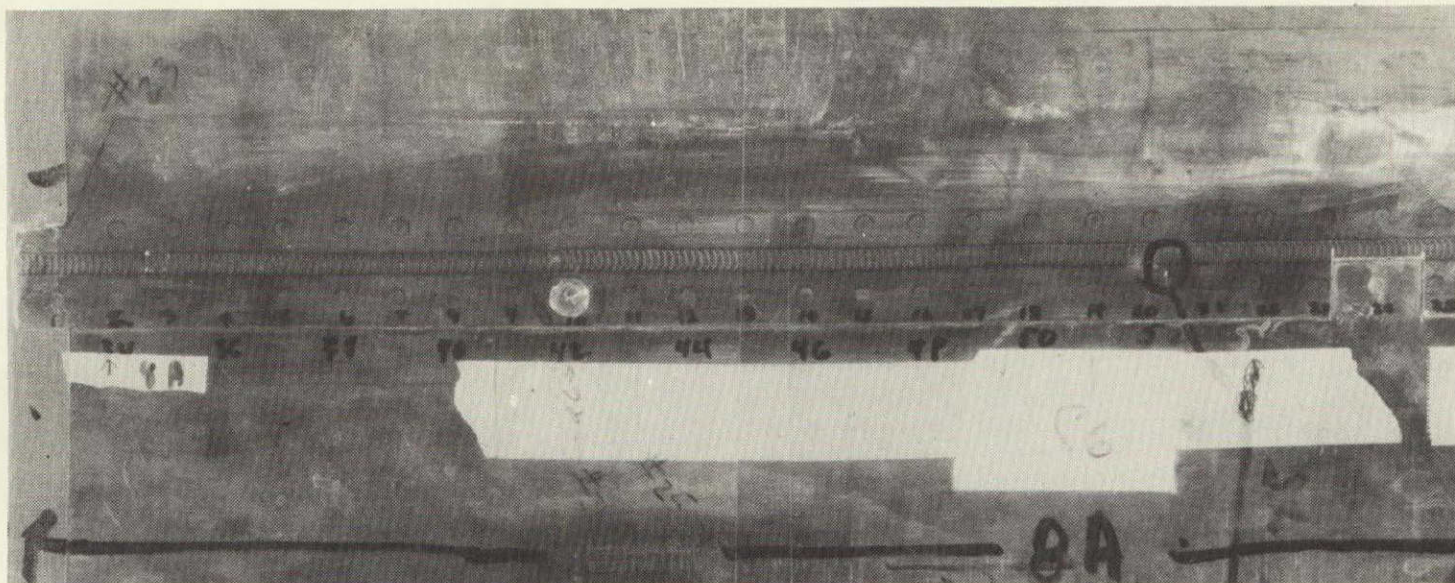
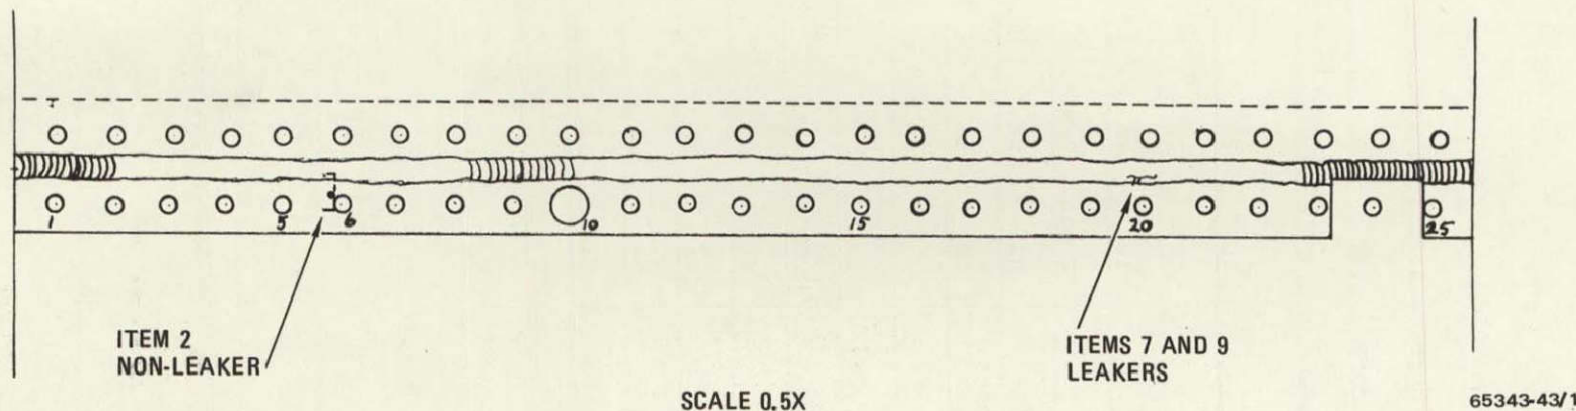
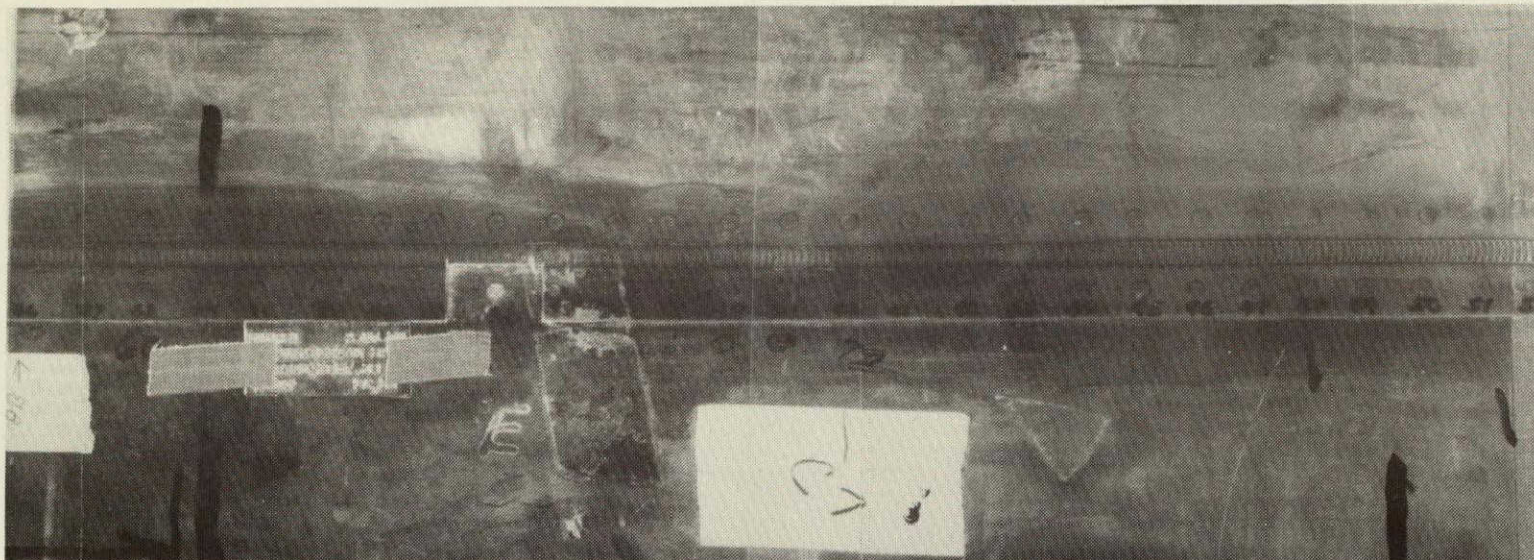
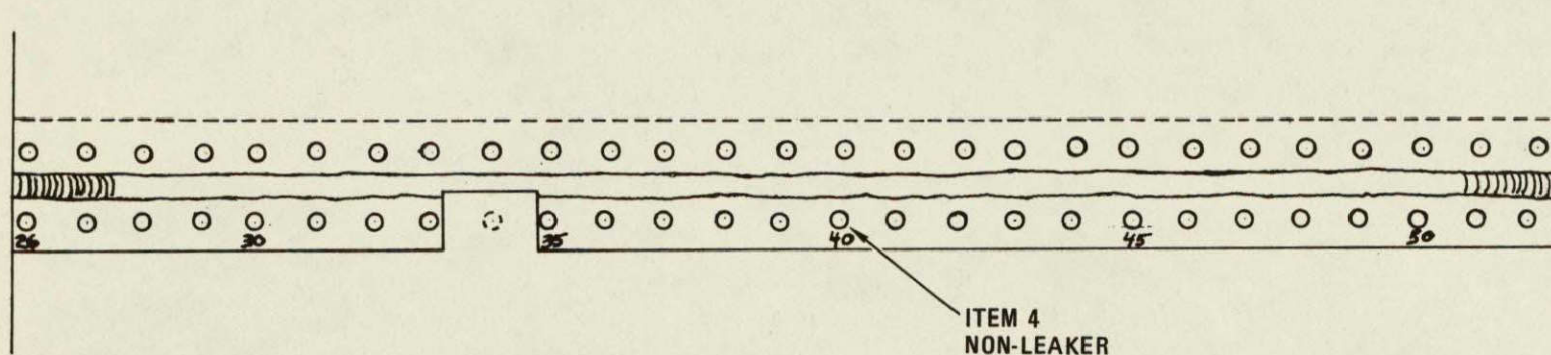
Figure 2-3. Outside Surface Appearance of Metallographic Specimen Panel No. 1 (see Figure 2-2)  
Aft Spotweld ID Numbers, and the Location of Items 2, 4, 7, and 9. (Sheet 1 of 2)

Figure 2-3. Outside Surface Appearance of Metallographic Specimen Panel No. 1 (see Figure 2-2)  
Aft Spotweld ID Numbers, and the Location of Items 2, 4, 7, and 9. (Sheet 2 of 2)

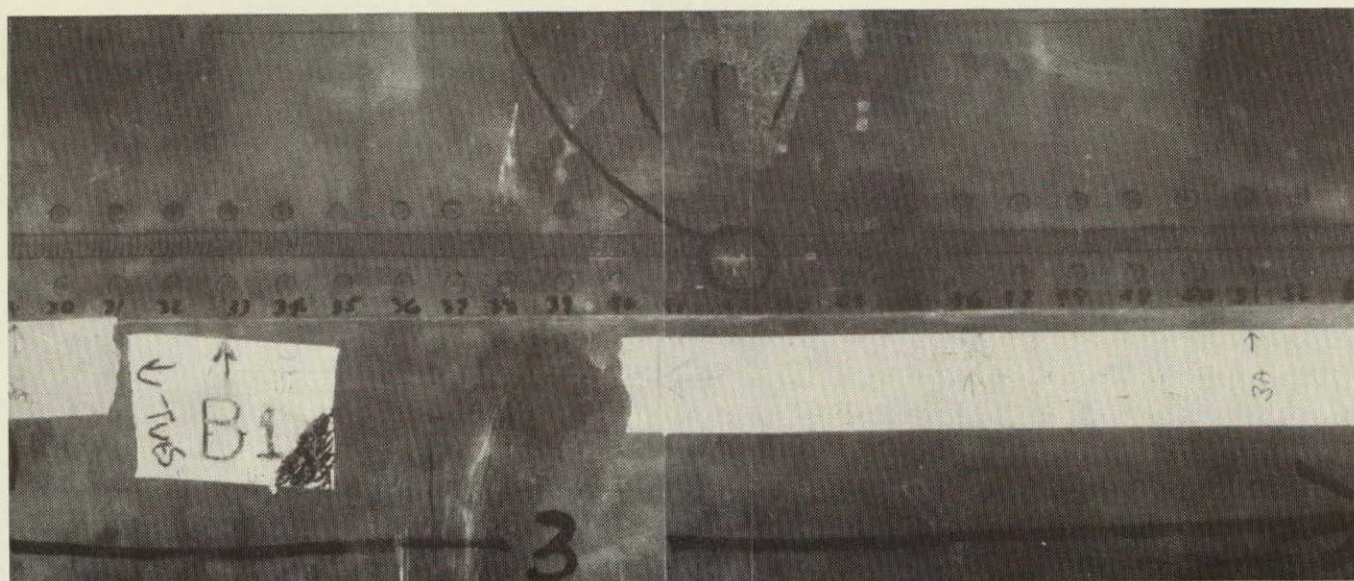
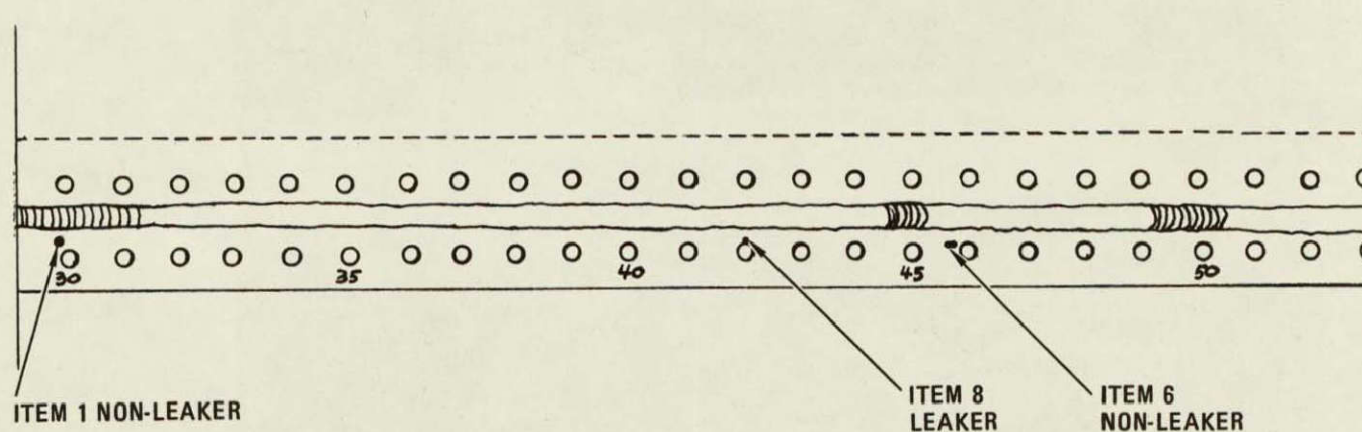
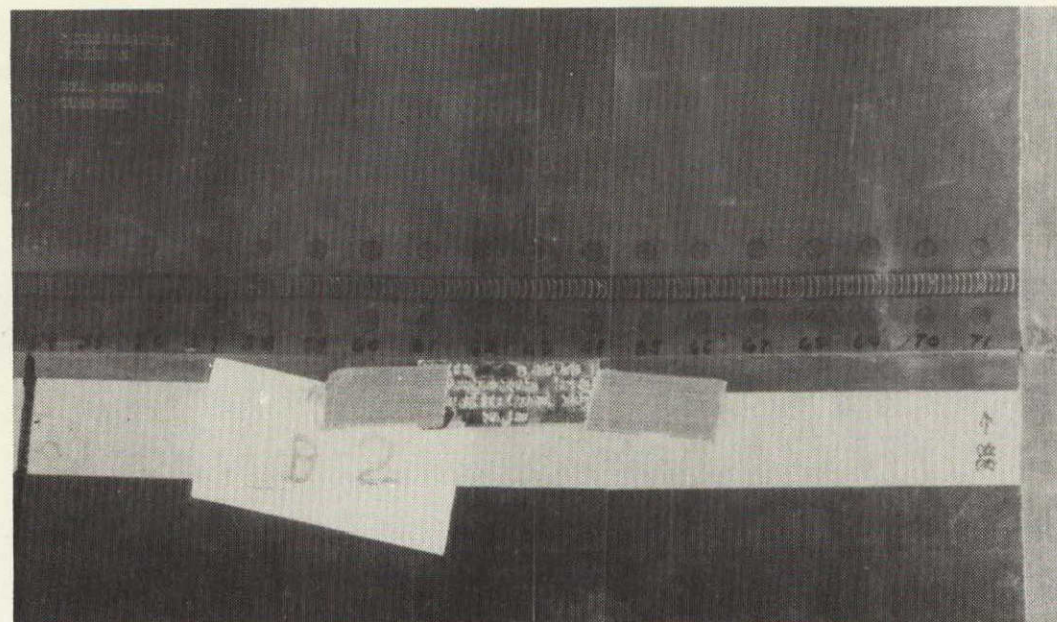
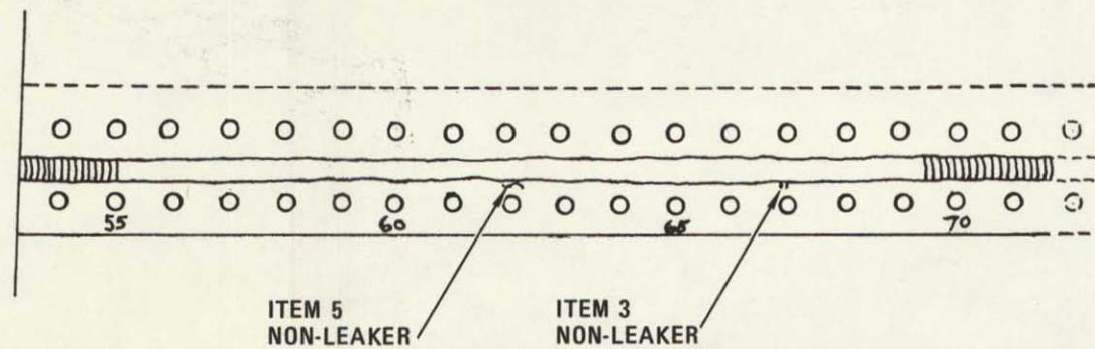
Figure 2-4. Outside Surface Appearance of Metallographic Specimen Panel No. 2 (see Figure 2-2), Aft Spotweld ID Number, the Location of Items 1, 3, 5, 6, 8, 11, and 12, and other Specimens as Noted. (Sheet 1 of 3)

Figure 2-4. Outside Surface Appearance of Metallographic Specimen Panel No. 2 (see Figure 2-2), Aft Spotweld ID Number, the Location of Items 1, 3, 5, 6, 8, 11, and 12, and other Specimens as Noted. (Sheet 2 of 3)

Figure 2-4. Outside Surface Appearance of Metallographic Specimen Panel No. 2 (see Figure 2-2), Aft Spotweld ID Number, the Location of Items 1, 3, 5, 6, 8, 11, and 12, and other Specimens as Noted. (Sheet 3 of 3)

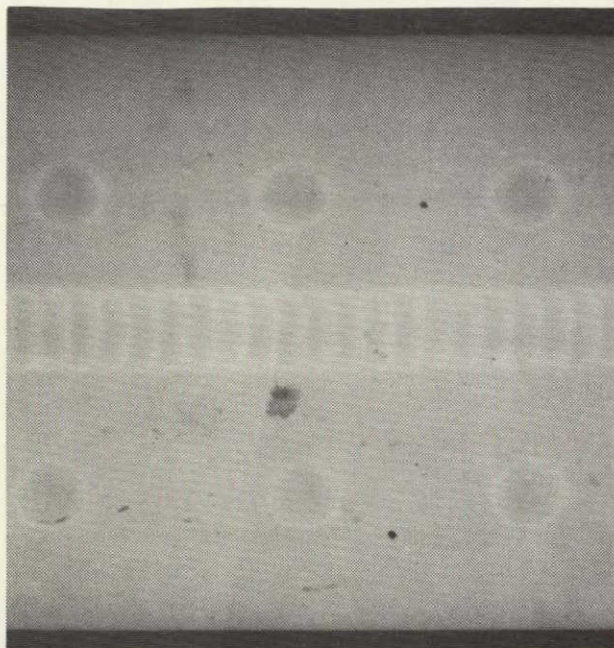
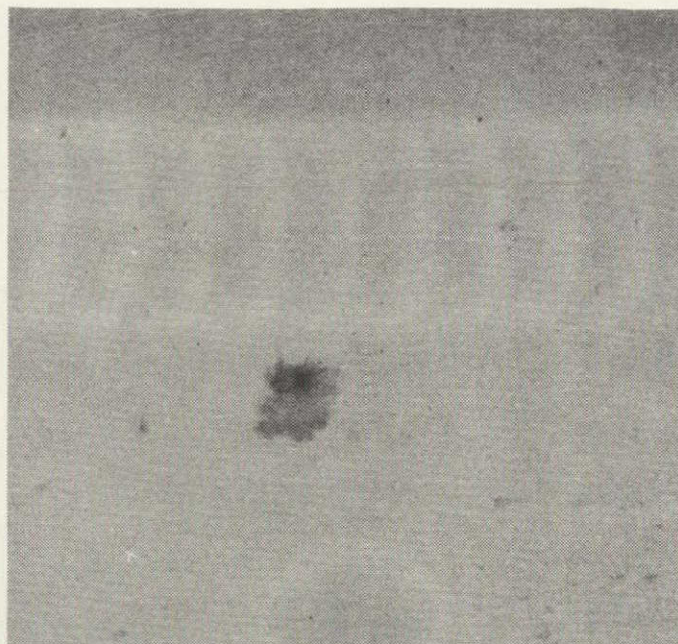
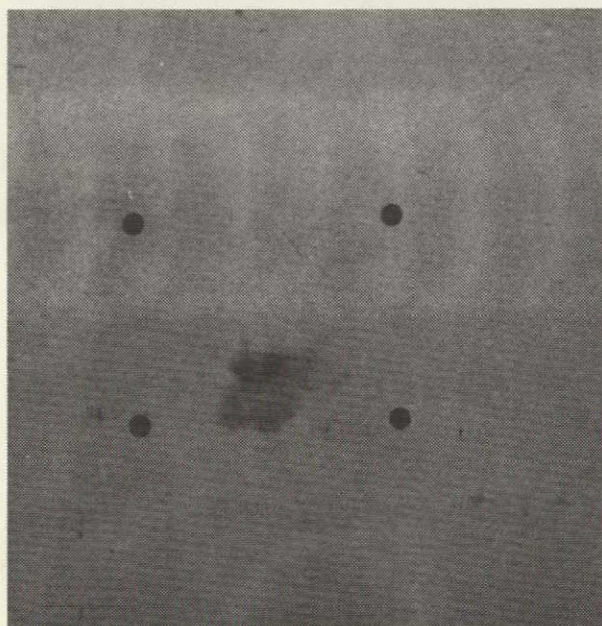
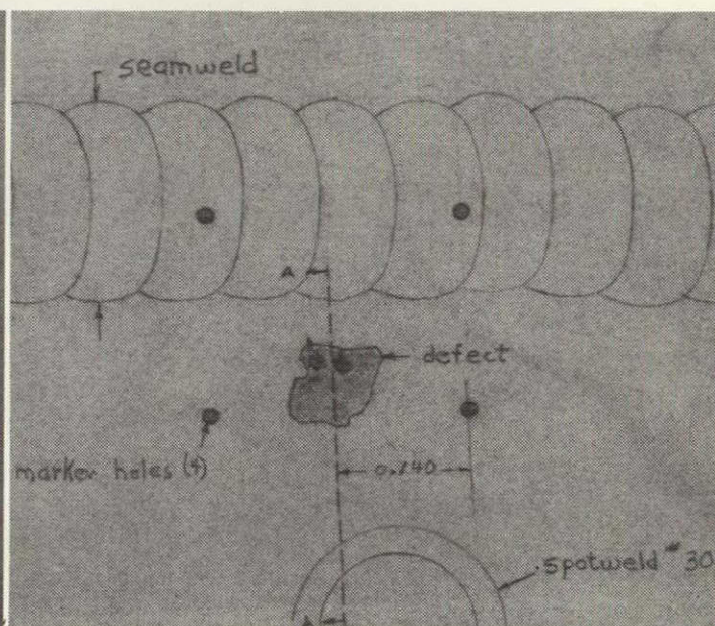
ABOVE - X-RAY IMAGE OF THE "ROUND" DEFECT AT 2X AND 5X MAGNIFICATIONS  
 - X-RAY FILM 5X5001, 3-3A, 2-17-76, DENSITY 2.41

BELOW - SAME DEFECT WITH FOUR 0.020 IN. DIA MARKER HOLES ADDED  
 - X-RAY FILM M1, MAY 1976, DENSITY 2.15

STA 1090

SPOTWELD 30

Figure 2-6. X-ray Appearance of a Round Defect Indication Near the Seamweld (Item 1) and the Location of a Section (A-A) Through the Defect (see Figure 2-7).

**2.3.5 ELEMENT ANALYSES, COMPARISON.** To obtain some information on the chemical nature of the laminated mixture of materials discovered in the low-density defect indications of Items 1 and 2 (Figures 2-6 and 2-9), semi-quantitative analyses for elements greater than atomic number 12 (Mg) were made in the defect area and, for comparison, on a similar sized area on the base metal (301 CRES) using the X-ray energy dispersive accessory on the scanning electron microscope. The results are presented in Figure 2-41. The white material (see Figure 2-8) in this laminated mixture was determined to be 301 CRES base metal.

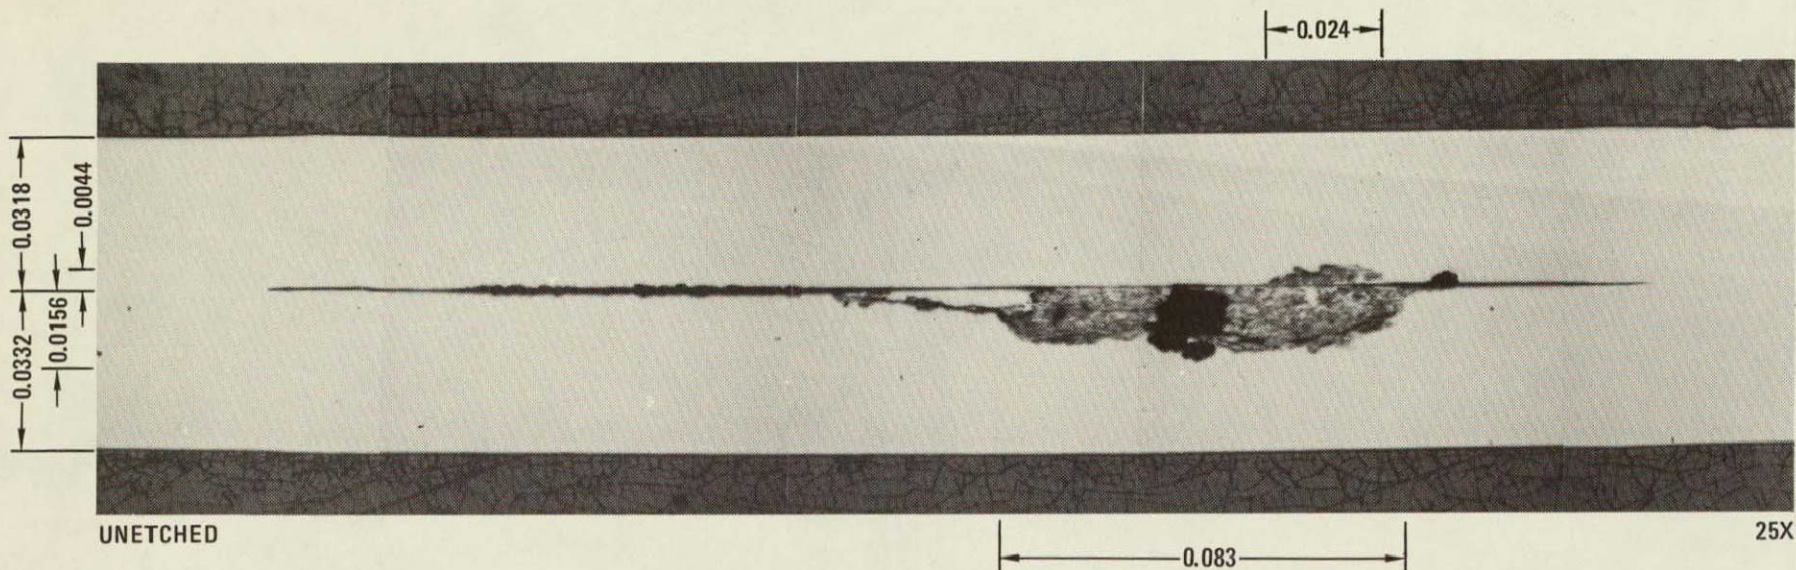
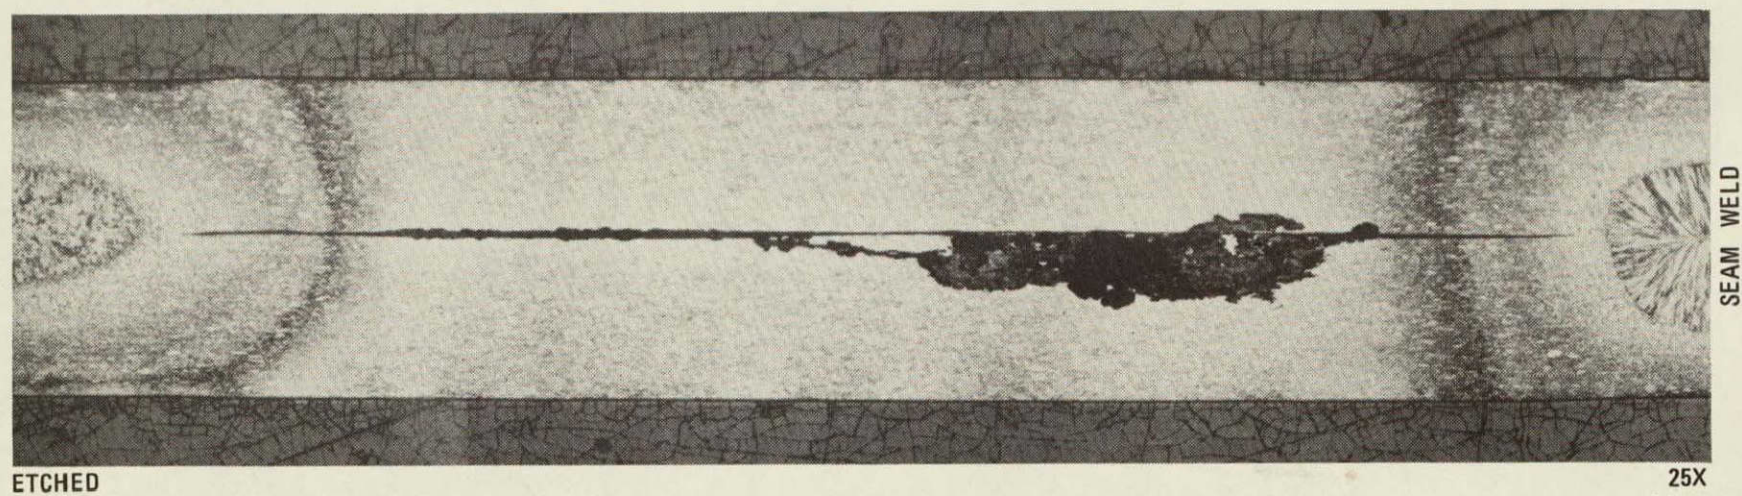
Figure 2-7. Appearance of Section A-A Through the Round, Pit-type Defect Indication Shown in Figure 2-6. A Portion of the Unetched Defect is Shown at 500X in Figure 2-8.

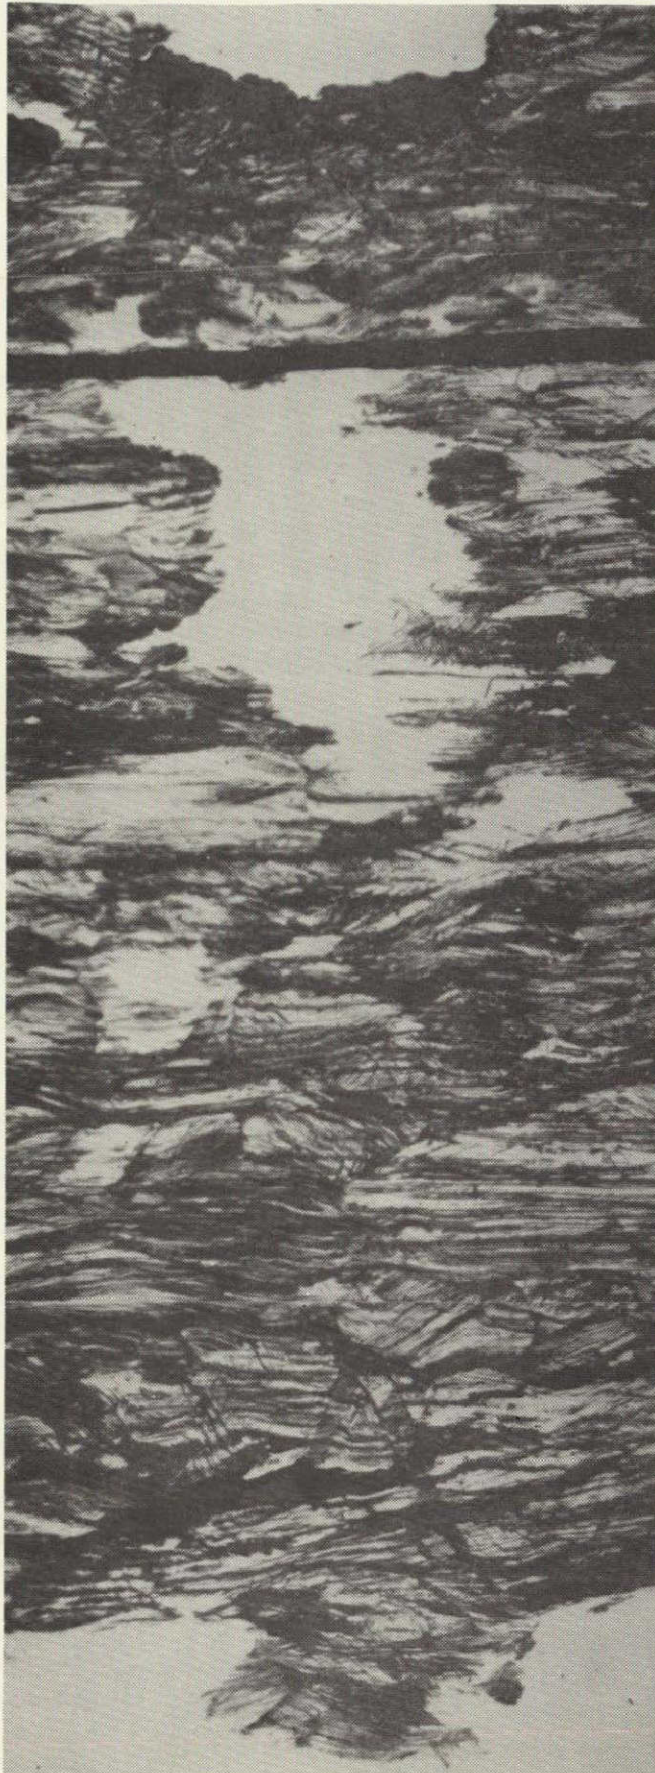
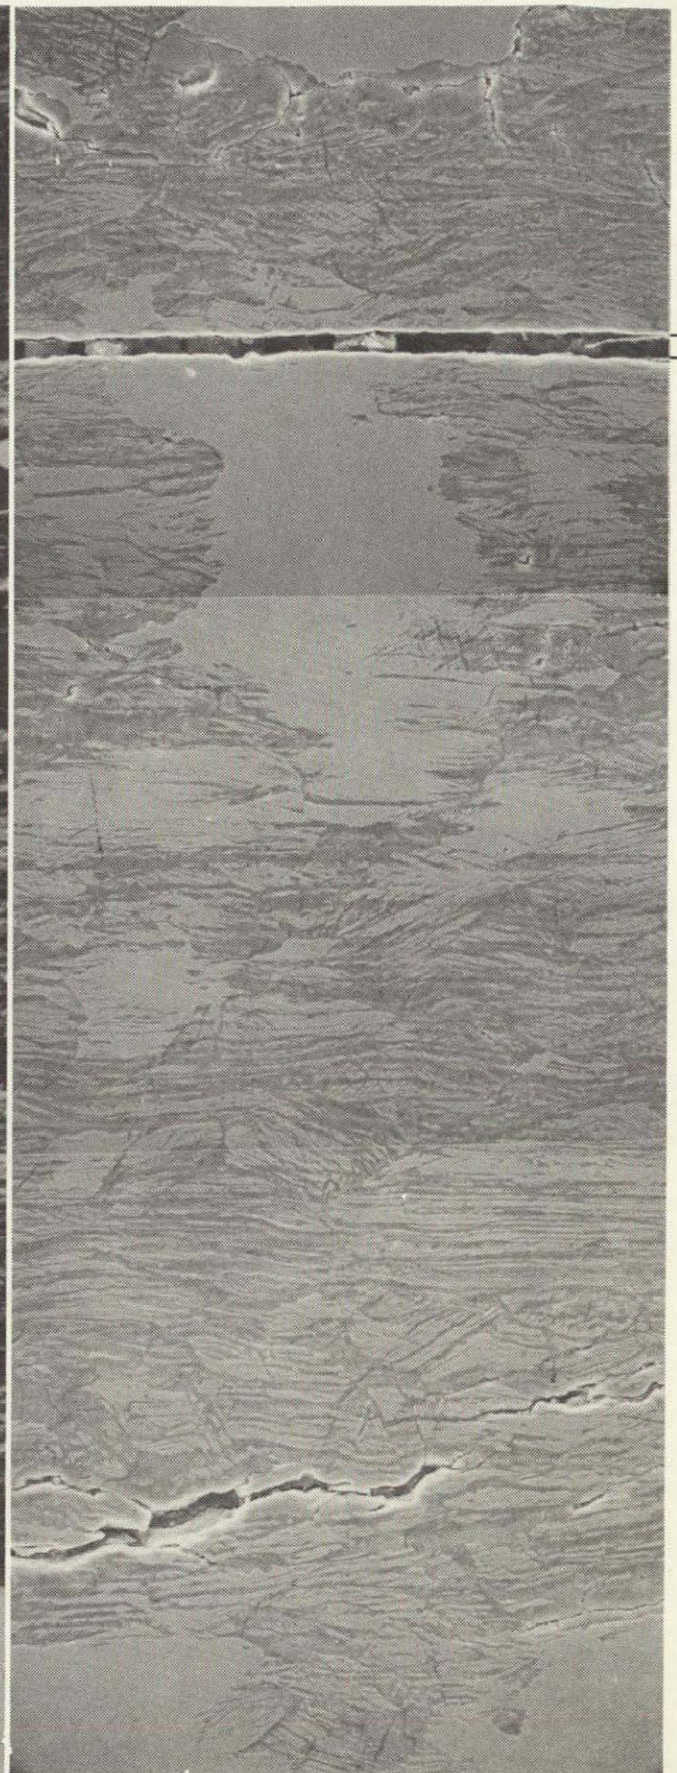
Figure 2-8. Portion of Unetched Defect Shown in Figure 2-7 at 500X Magnification

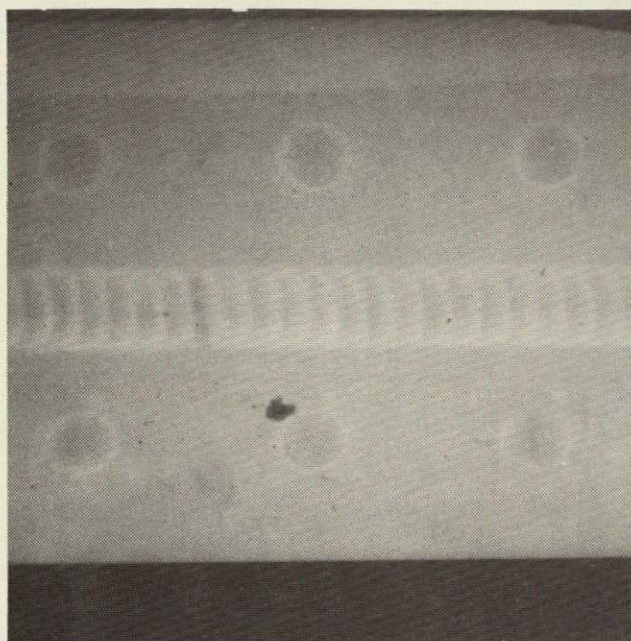
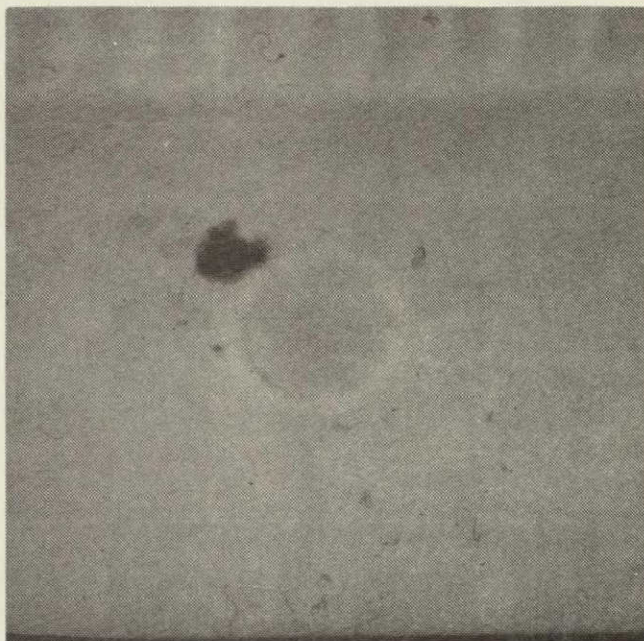
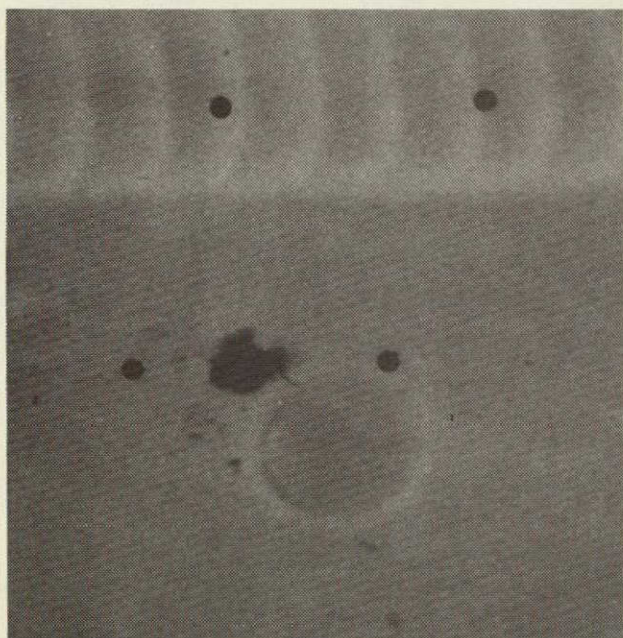
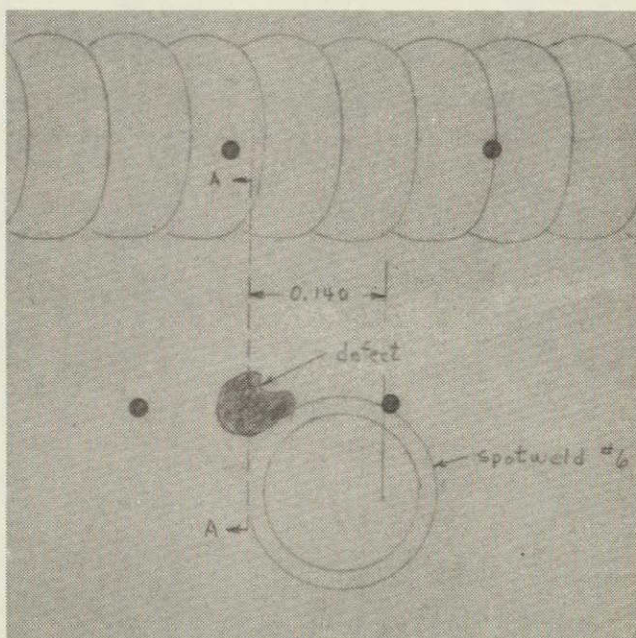
ABOVE - X-RAY IMAGE OF THE "ROUND" DEFECT MAGNIFIED 2 AND 5X  
 - X-RAY FILM 5X5001, 8A-8B, 2-17-76, DENSITY 2.14

BELOW - SAME DEFECT WITH FOUR MARKER HOLES ADDED  
 - X-RAY FILM M2, 5-12-76, DENSITY 3.38

STA 1057 SPOTWELD 6

Figure 2-9. X-ray Appearance of a Round Defect Indication Near a Spotweld (Item 2) and the Location of a Section (A-A) Through the Defect (See Figure 2-10)

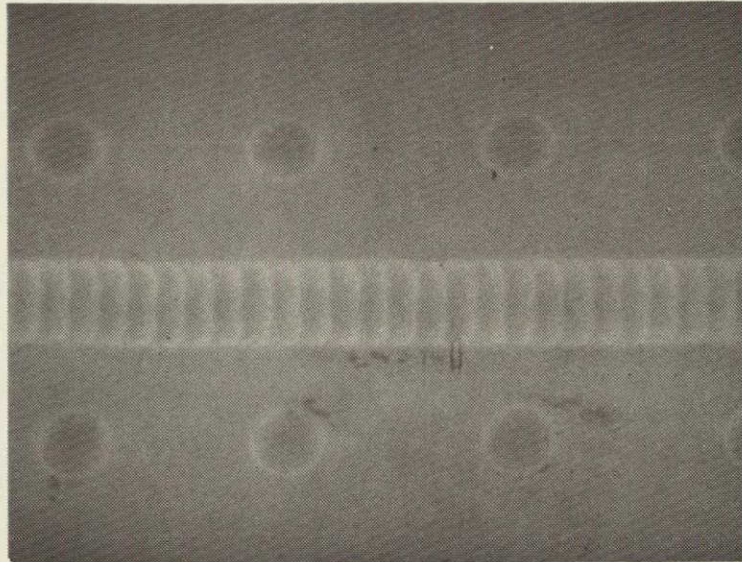
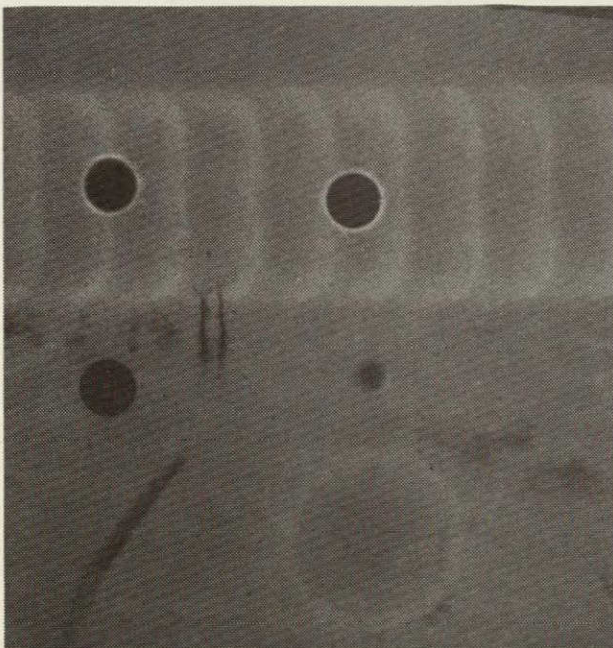
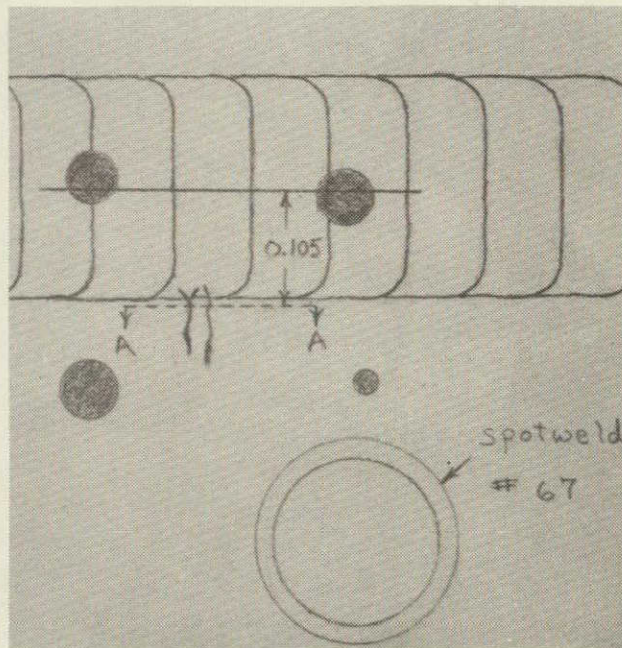
ABOVE - X-RAY IMAGE OF THE DEFECTS MAGNIFIED 2X  
- X-RAY FILM 5X5001, 3A-3B, 2-17-76

BELOW - SAME DEFECTS MAGNIFIED 5X WITH 4 MARKER HOLES ADDED  
- X-RAY FILM 3K6031, 3-2-76

STA 1090 SPOTWELD 67

Figure 2-11. X-ray Appearance of a Vertical, Crack-type Defect Indications at the Seamweld (Item 3), and the Location of a Section (A-A) through the Defects (see Figures 2-12 and 2-13)

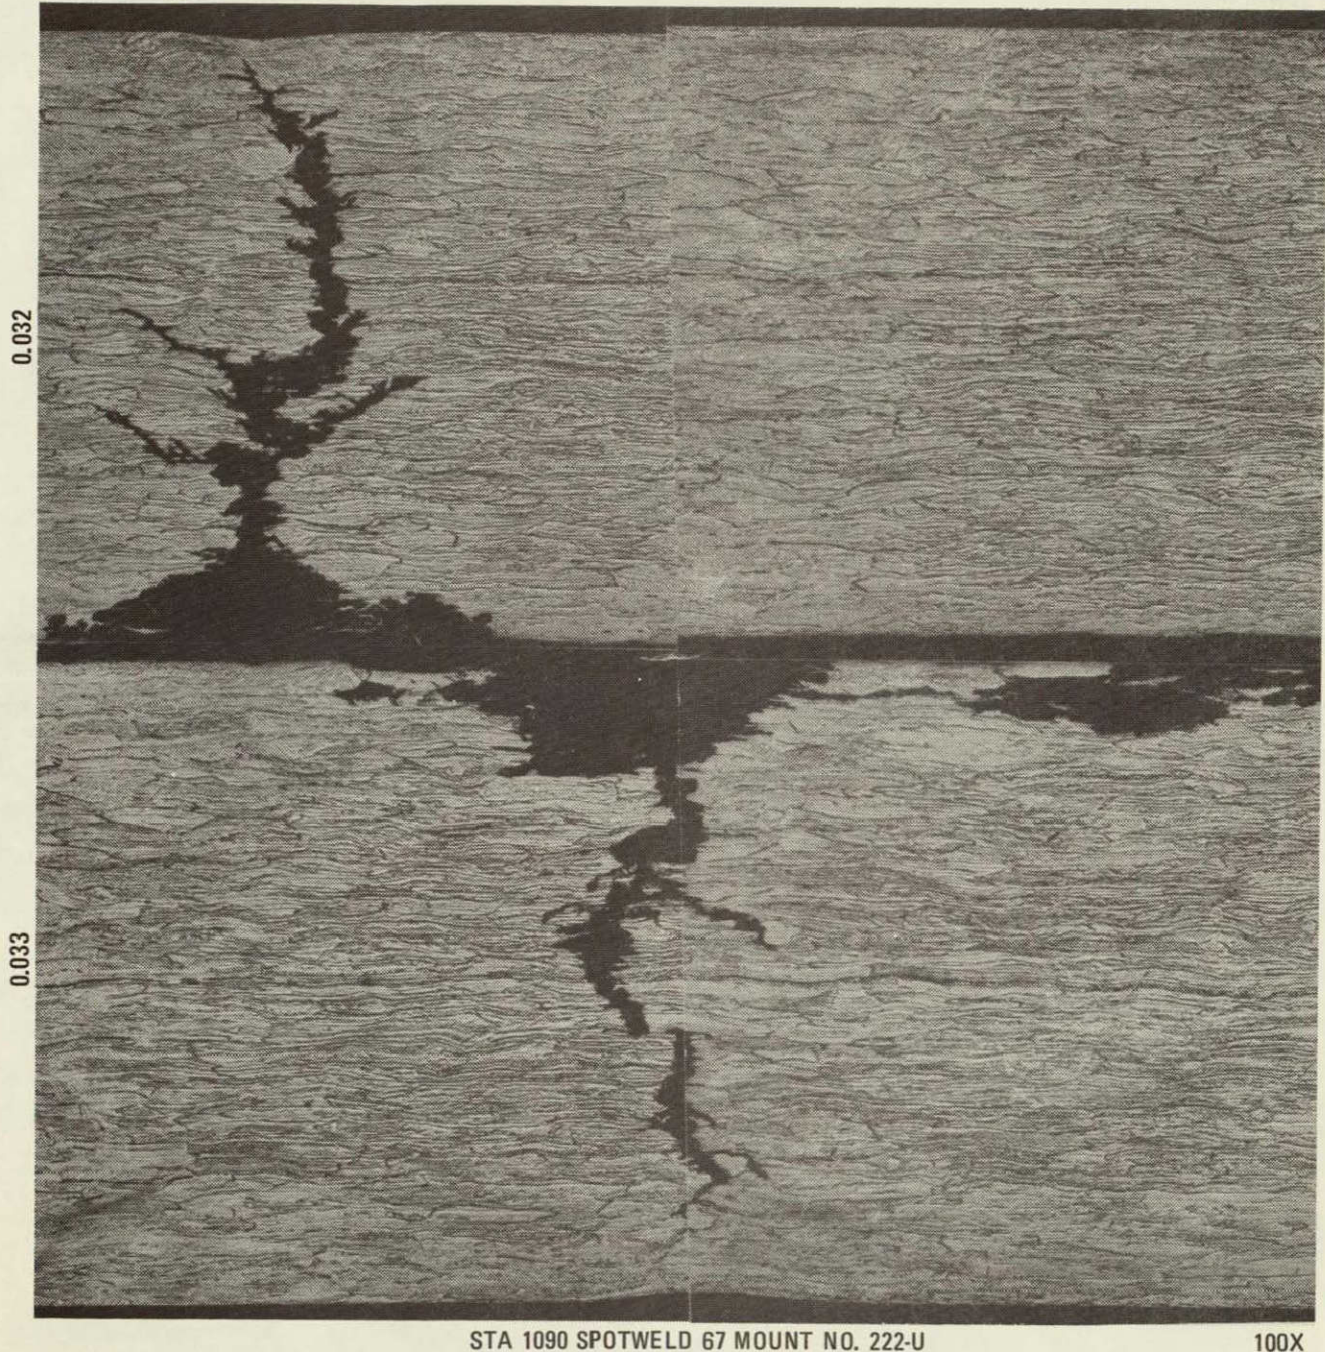
Figure 2-13. Etched Appearance of Section A-A Through the Crack-type Defect  
Indications Shown in Figure 2-11

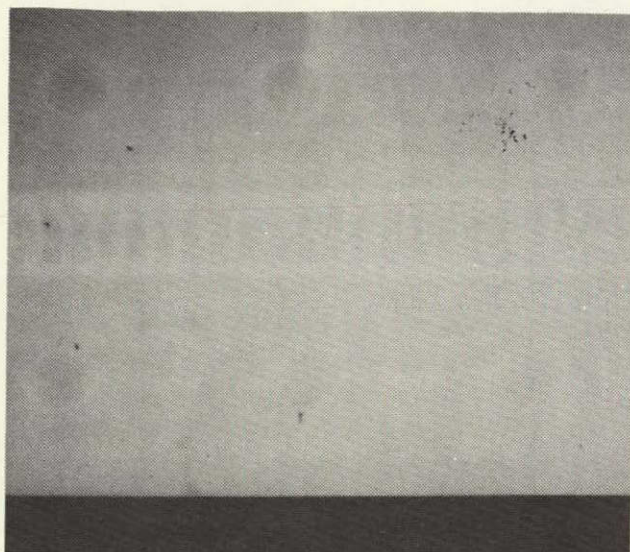
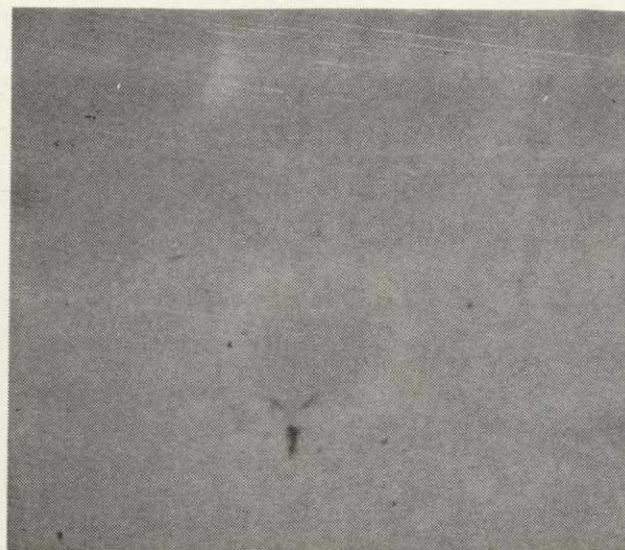
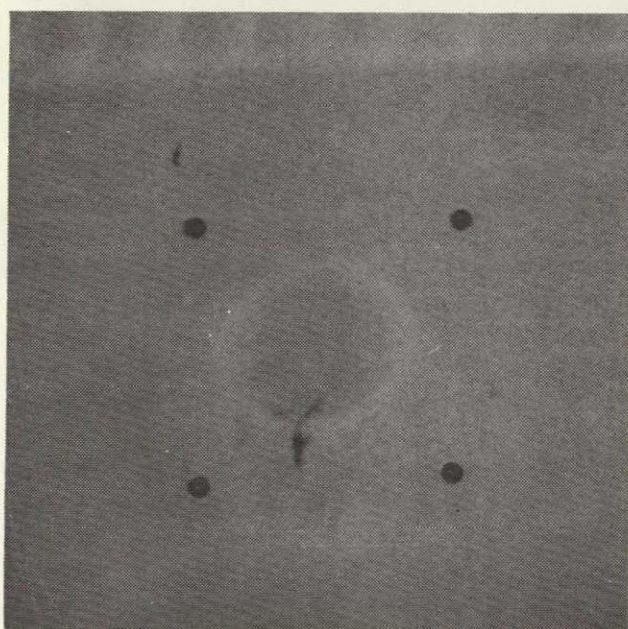
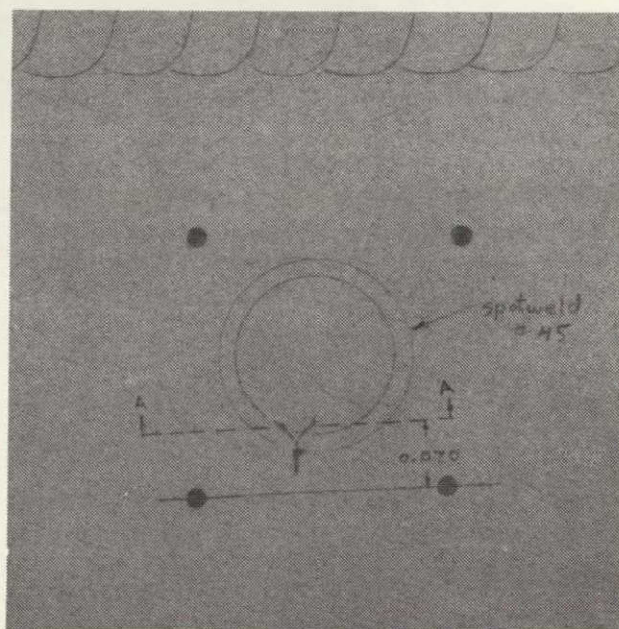
ABOVE — X-RAY IMAGE OF THE DEFECT MAGNIFIED 2 AND 5X  
 — X-RAY FILM 5X5001, 8B-9, 2-17-76, DENSITY 2.04

BELOW — SAME DEFECT WITH 4 MARKER HOLES ADDED  
 — X-RAY FILM M4, 5-12-76, DENSITY 3.35

STA 2057 SPOTWELD 45

Figure 2-14. X-ray Appearance of a Vertical, Crack-type Defect Indication Near a Spotweld (Item 4), and the Location of a Section (A-A) Through the Defect (see Figure 2-15)

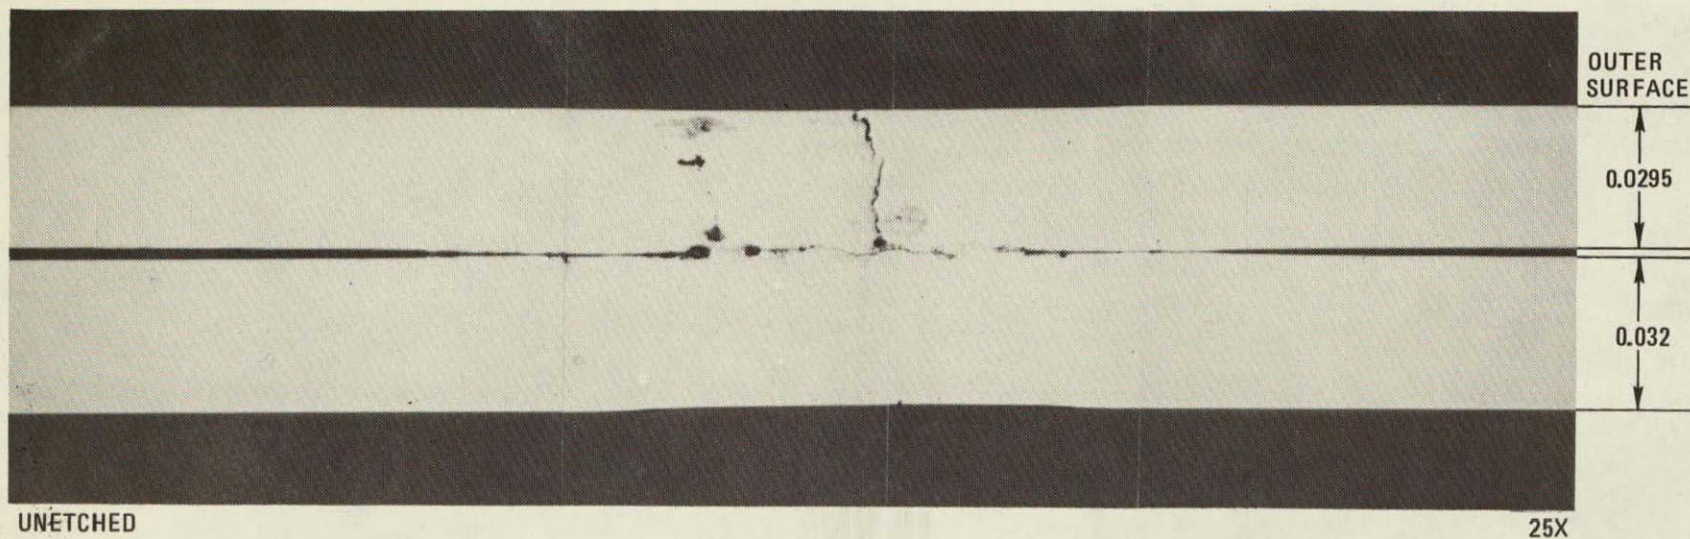
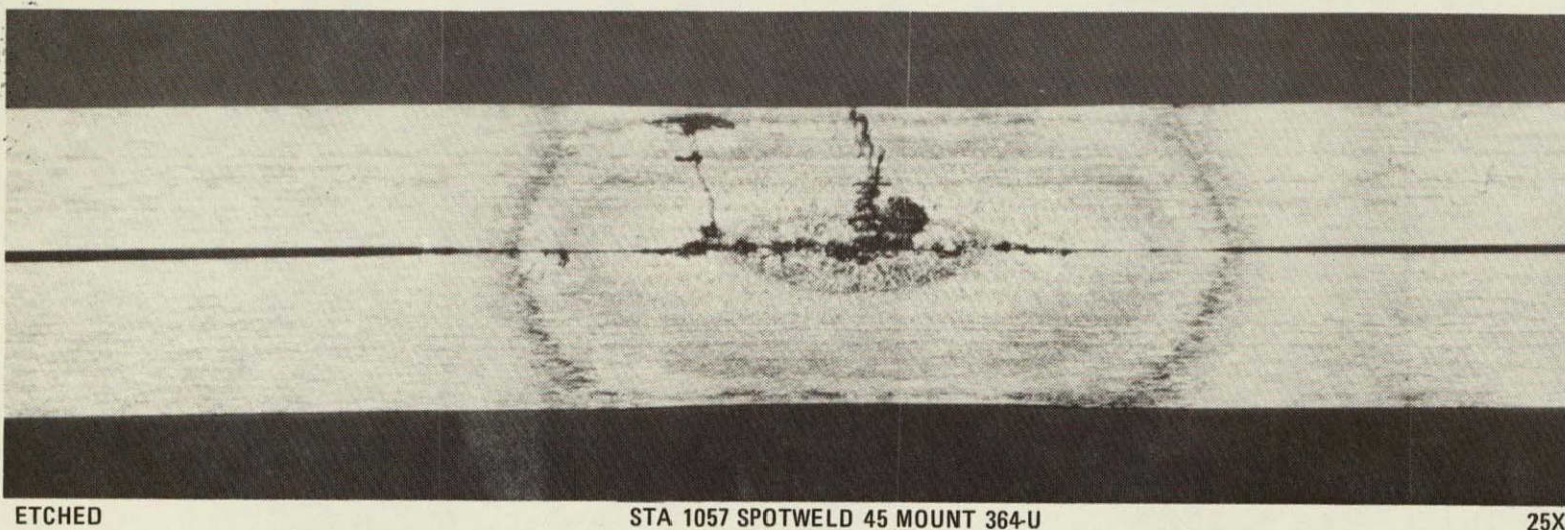
Figure 2-15. Appearance of Section A-A Through the Crack-type Defect Indication Shown in Figure 2-14

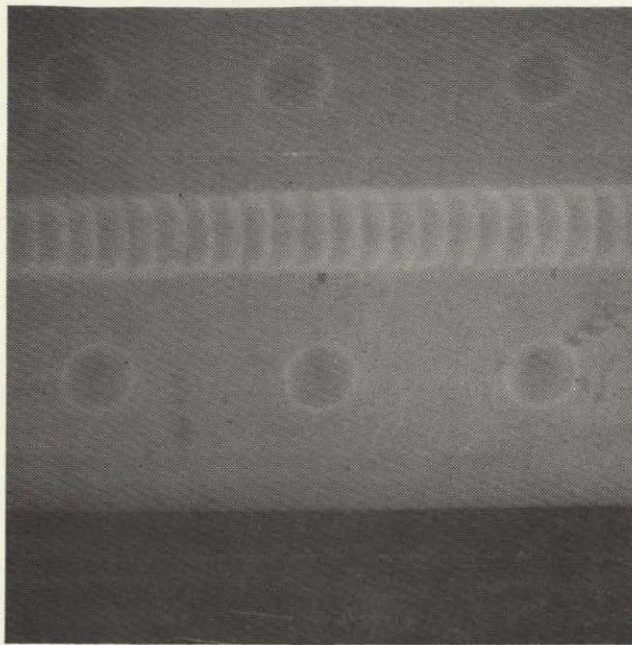
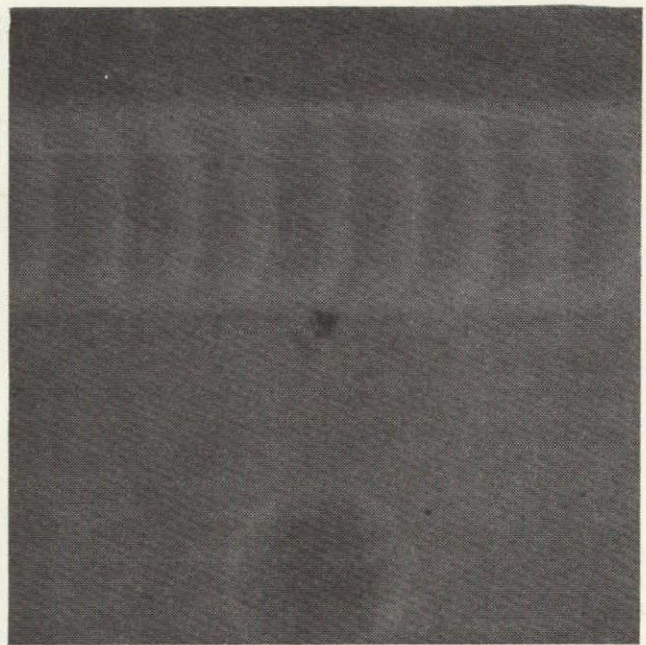
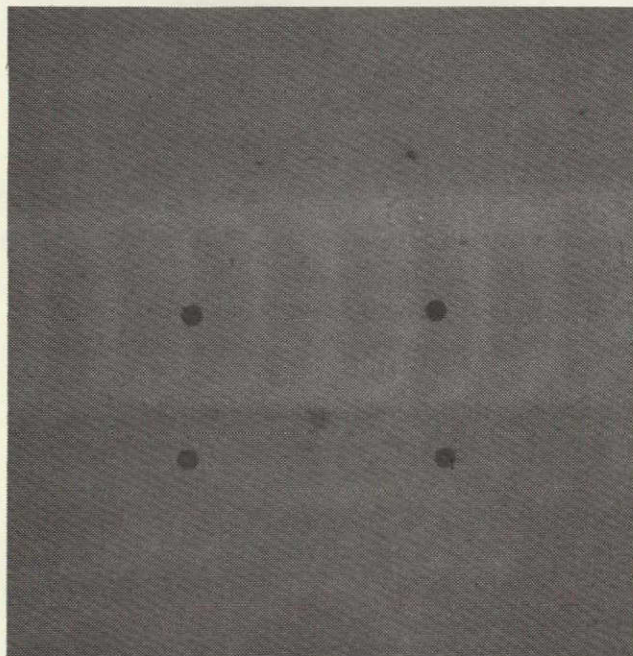
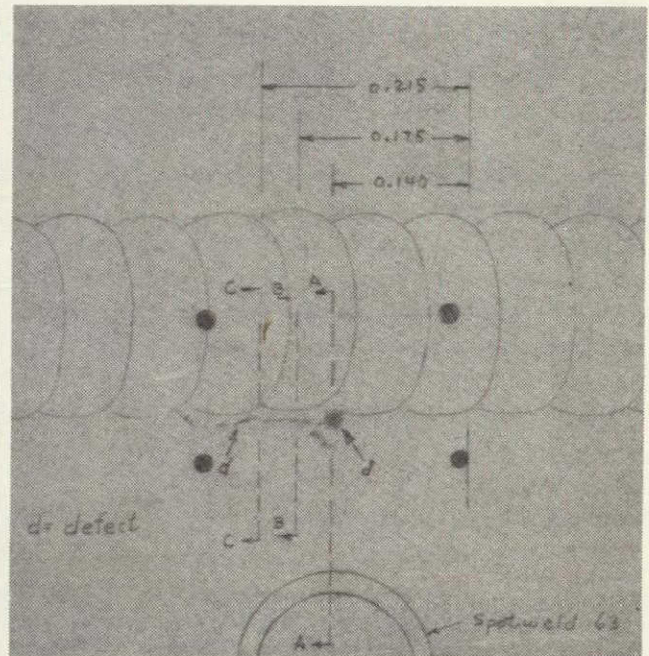
ABOVE - X-RAY IMAGE OF THE DEFECT MAGNIFIED 2 AND 5X  
 - X-RAY FILM 5X5001, 3A-3B, 2-17-76, DENSITY 2.78

BELOW - SAME DEFECT WITH 4 MARKER HOLES ADDED  
 - X-RAY FILM M5, 5-12-76, DENSITY 2.14

STA 1090 NEAR SPOTWELD 63

Figure 2-16. X-ray Appearance of a Horizontal, "Length" Defect Indication Adjacent to the Seamweld (Item 5) and the Locations of Three Sections (A-A, B-B, and C-C) Through the Defect (see Figures 2-17 through 2-21)
